**BLACKSTONE RIVER BASIN
AUBURN, MASSACHUSETTS**

**UPPER STONEVILLE DAM
MA 00196**

PHASE I INSPECTION REPORT NATIONAL DAM INSPECTION PROGRAM

APRIL 1979

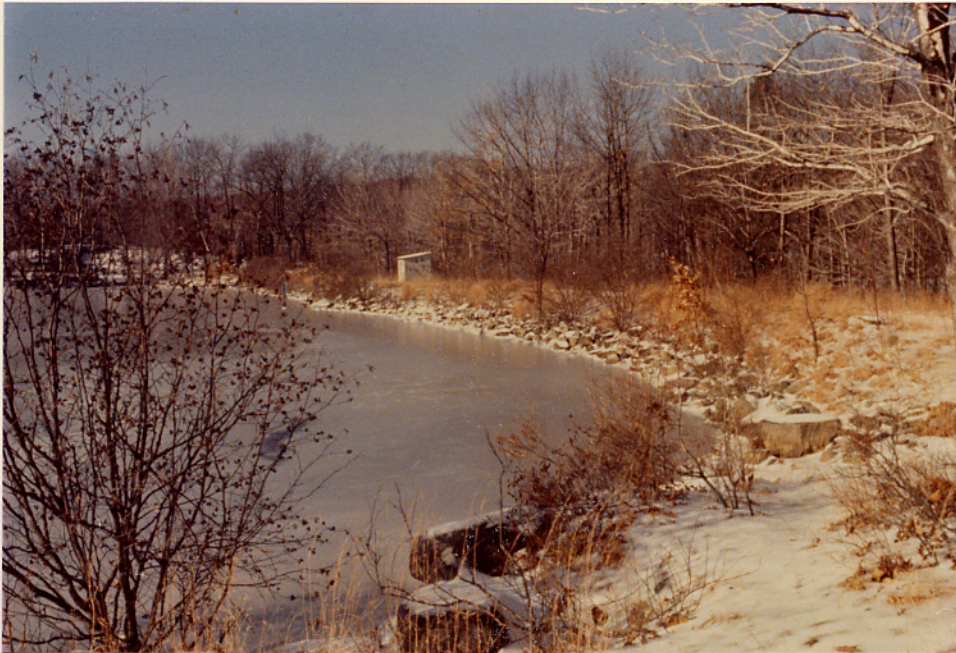
NO. 1 UPSTREAM VIEW OF DAM

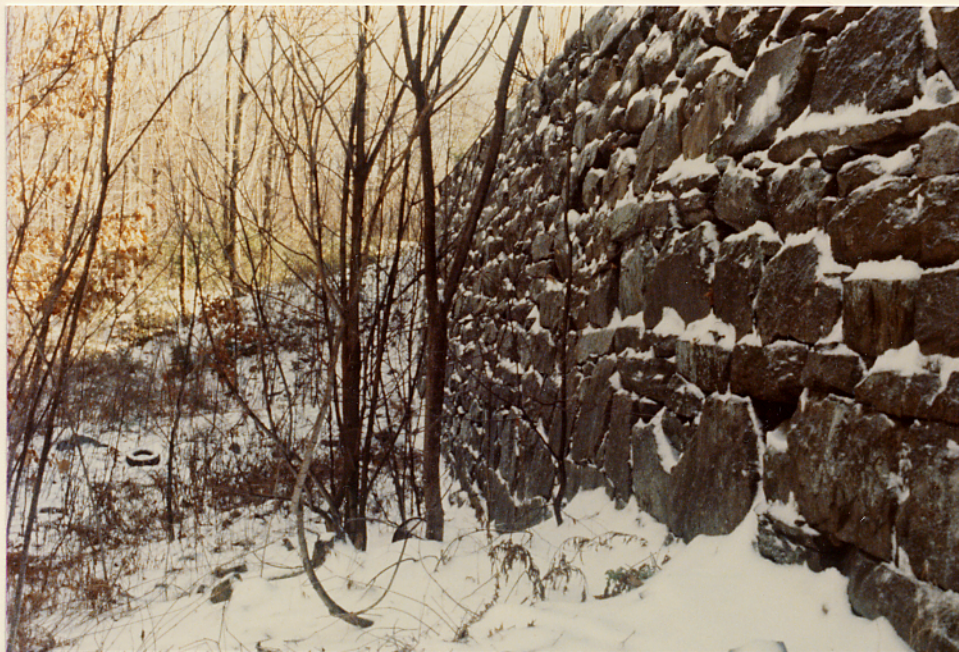
The downstream wall consisting of random sized dry stone masonry was apparently constructed with a slight outward batter. Voids between the large stone are evidence of smaller stones being dislodged throughout the years. A visual inspection of the downstream wall indicated it to be in fair to poor condition. The number of voids in the wall where smaller stones have fallen out indicate areas which should be repaired. Throughout the face of the stone wall, vertical fractures were noted in the stone blocks.

In the downstream area near the east abutment, many cobble size rocks have apparently been dumped. Seepage was noted at approximately

the location where the wall reaches its maximum wall height (about 300 feet from the west abutment). About 100 to 200 feet downstream of the east abutment, a swampy area with a considerable water surface was observed. This could be a possible location of seepage.

NO. 2 DOWNSTREAM FACE OF DAM

- (1) open both slide gates and drain the pond to invert El 567.9 until all the recommendations and remedial measures have been implemented.
- (2) insure that the low-level outlet is operational;
- (3) repair the downstream masonry wall after conducting the investigation recommended above;
- (4) selective removal of trees and brush from the crest, upstream slope and downstream area of the dam and fill resulting excavations;
- (5) repair the concrete along the spillway and gate house to prevent further deterioration;
- (6) maintain the spillways and discharge channels free from accumulated debris;
- (7) replace riprap on upstream embankment between the dam and main spillway;
- (8) implement a systematic program of maintenance inspections. As a minimum, the inspection program should consist of a

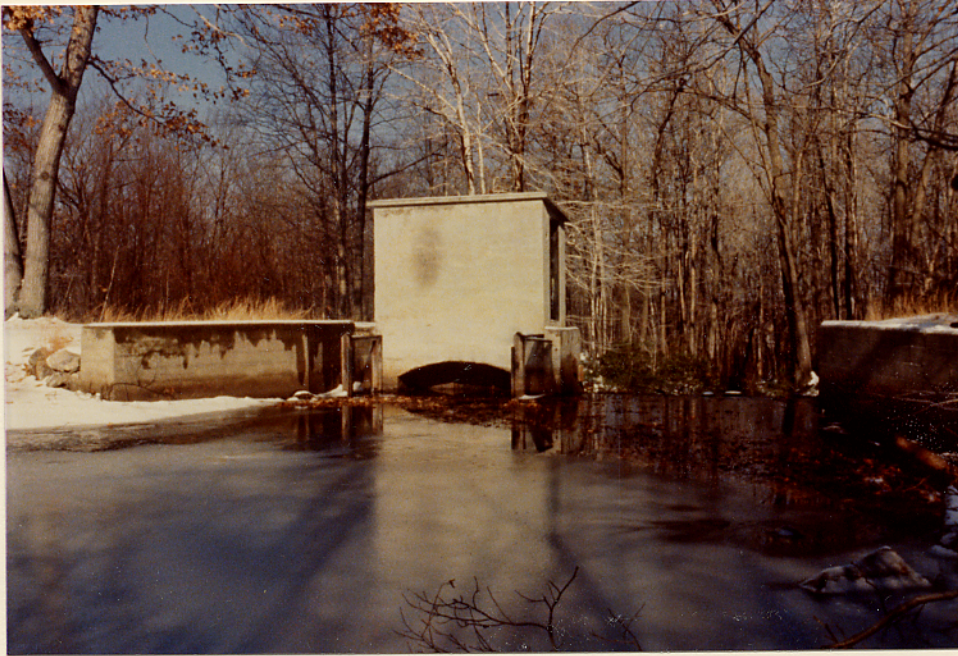
- c. Appurtenant Structures. Both the main and auxiliary spillways appeared in fair to good condition. The concrete was sound at the main spillway although some minor spalling and efflorescence were noted at the walls. The ogee section of the spillway was slightly pitted. The concrete at the auxiliary spillway was in generally good condition although the weir was pitted. There were no flashboards in place at the main spillway while the flashboards at the auxiliary spillway, consisting of 18-inch high frame and plywood panels, were in poor condition. The flashboards were supported to the frames by steel pins.

NO. 3 UPSTREAM VIEW OF MAIN SPILLWAY

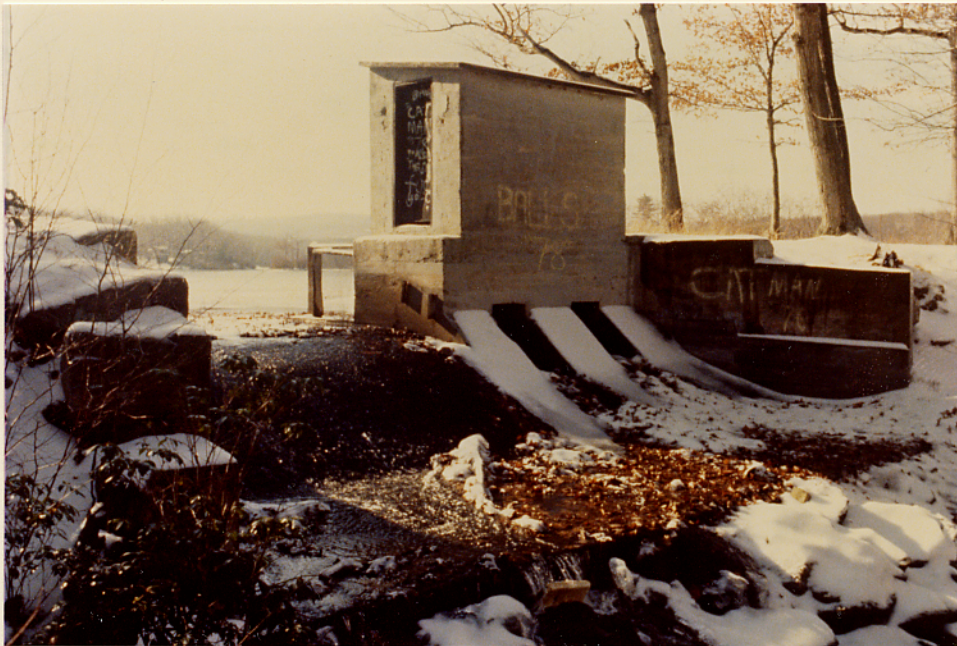
The slide gates at the main spillway were in operable condition according to the owner. The stems and operators for the gates, which were in good condition, were enclosed in a locked gate house. Both gates were leaking severely from the bottom and sides. Possibly some debris prevented fully closing the gates. The concrete at the outlet showed some minor spalling.

NO. 4 DOWNSTREAM VIEW OF MAIN SPILLWAY AND GATE HOUSE

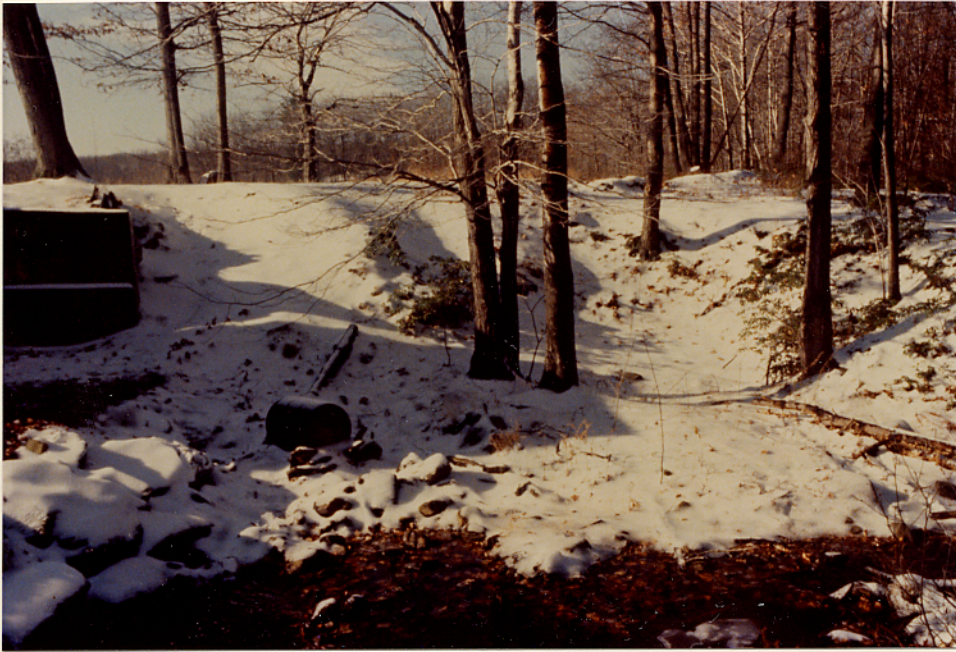
NO. 5 LOW AREAS ADJACENT TO MAIN SPILLWAY

randomly located fractures in the stone blocks. In addition, riprap near the main spillway should be replaced. The low level outlet gates should be repaired. Small trees and brush should be removed from the crest of the dam and downstream area.

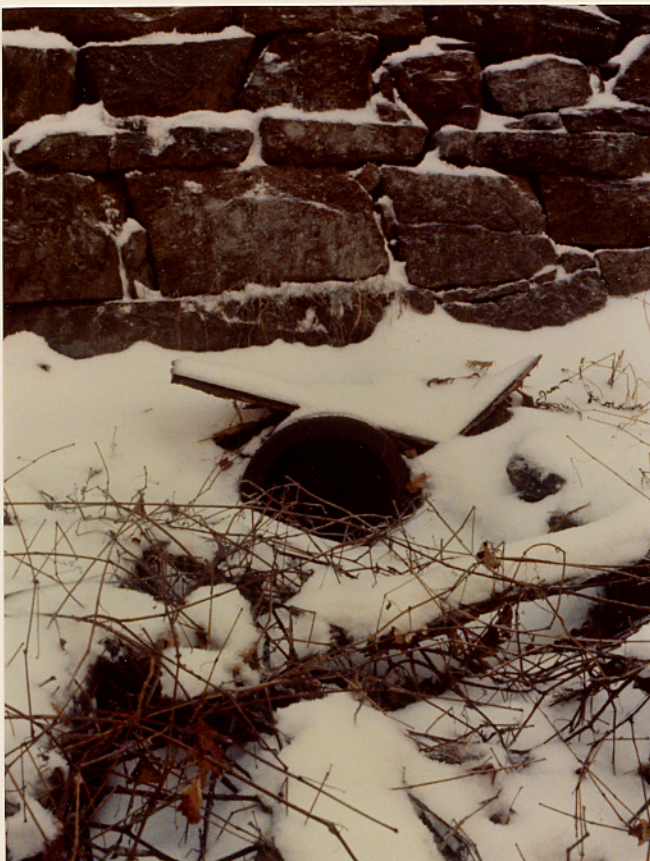
The low level outlet at the middle of the dam, consists of a 15-inch diameter cast iron pipe. The outlet valve was leaking approximately 2 to 5 gallons per minute. The valve for the outlet has not been operated for at least the past five years and was not operational for this inspection. The concrete portion of the gate house was in poor condition although the stone masonry wall appeared in good condition.

- The low level outlet at the middle of the dam is not maintained and apparently has not been operated with-in the recent past (at least five years). The outlet leaks as water was observed discharging from the pipe.

NO. 6 OUTLET CONDUIT AT DOWNSTREAM WALL OF DAM

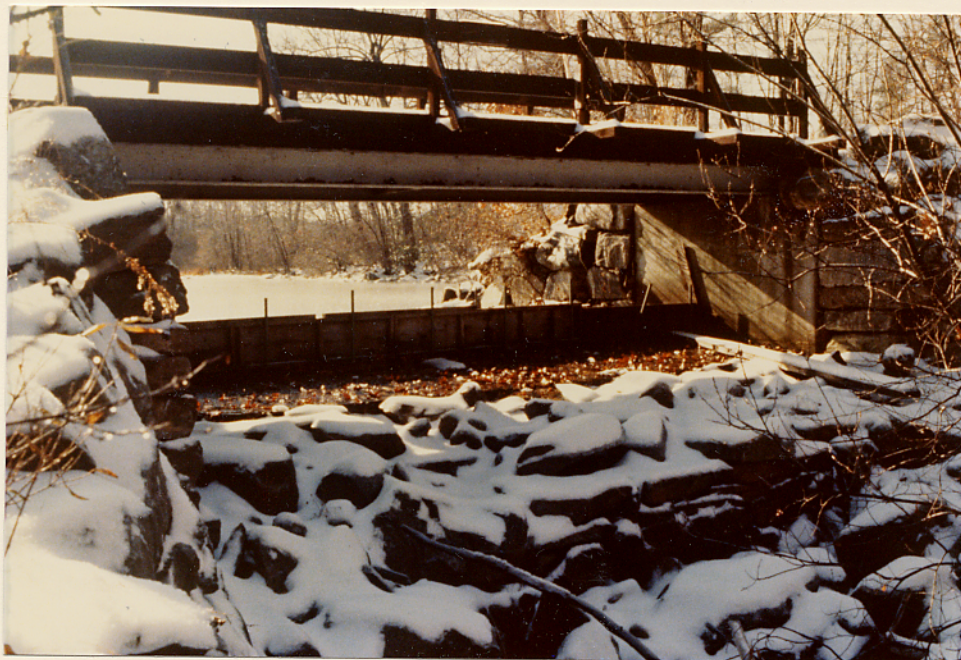
The dry stone masonry training walls at the auxiliary spillway were in fair condition as many voids and loose stones were observed. There was also a log boom laying across the auxiliary spillway to prevent debris from reaching the spillway. The approaches to both spillways were in fair condition at the time of the inspection. Leaves and a few tree limbs had accumulated at the crest of the spillway.

**NO. 7 DOWNSTREAM VIEW OF AUXILIARY
SPILLWAY WITH FLASHBOARDS**

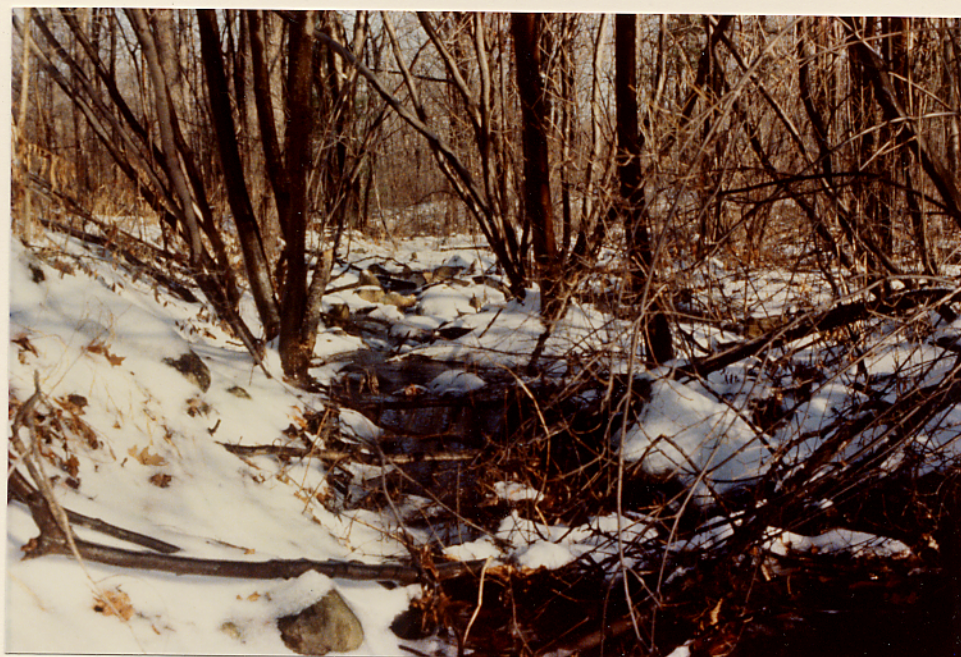
- d. Visual Observations. Both spillways appear in fair to good condition. Minor efflorescence and spalling was noted. The flashboards had been removed from the main spillway but were in place at the auxiliary spillway. The approach and discharge channels were not clogged but there were leaves, small trees and boulders in the discharge channel.

NO. 8 DISCHARGE CHANNEL BELOW AUXILIARY SPILLWAY
